DECLARATION OF SPECIAL AGENT STEVEN FRITH

Introduction

A. Vetting Inspections by BP Shipping

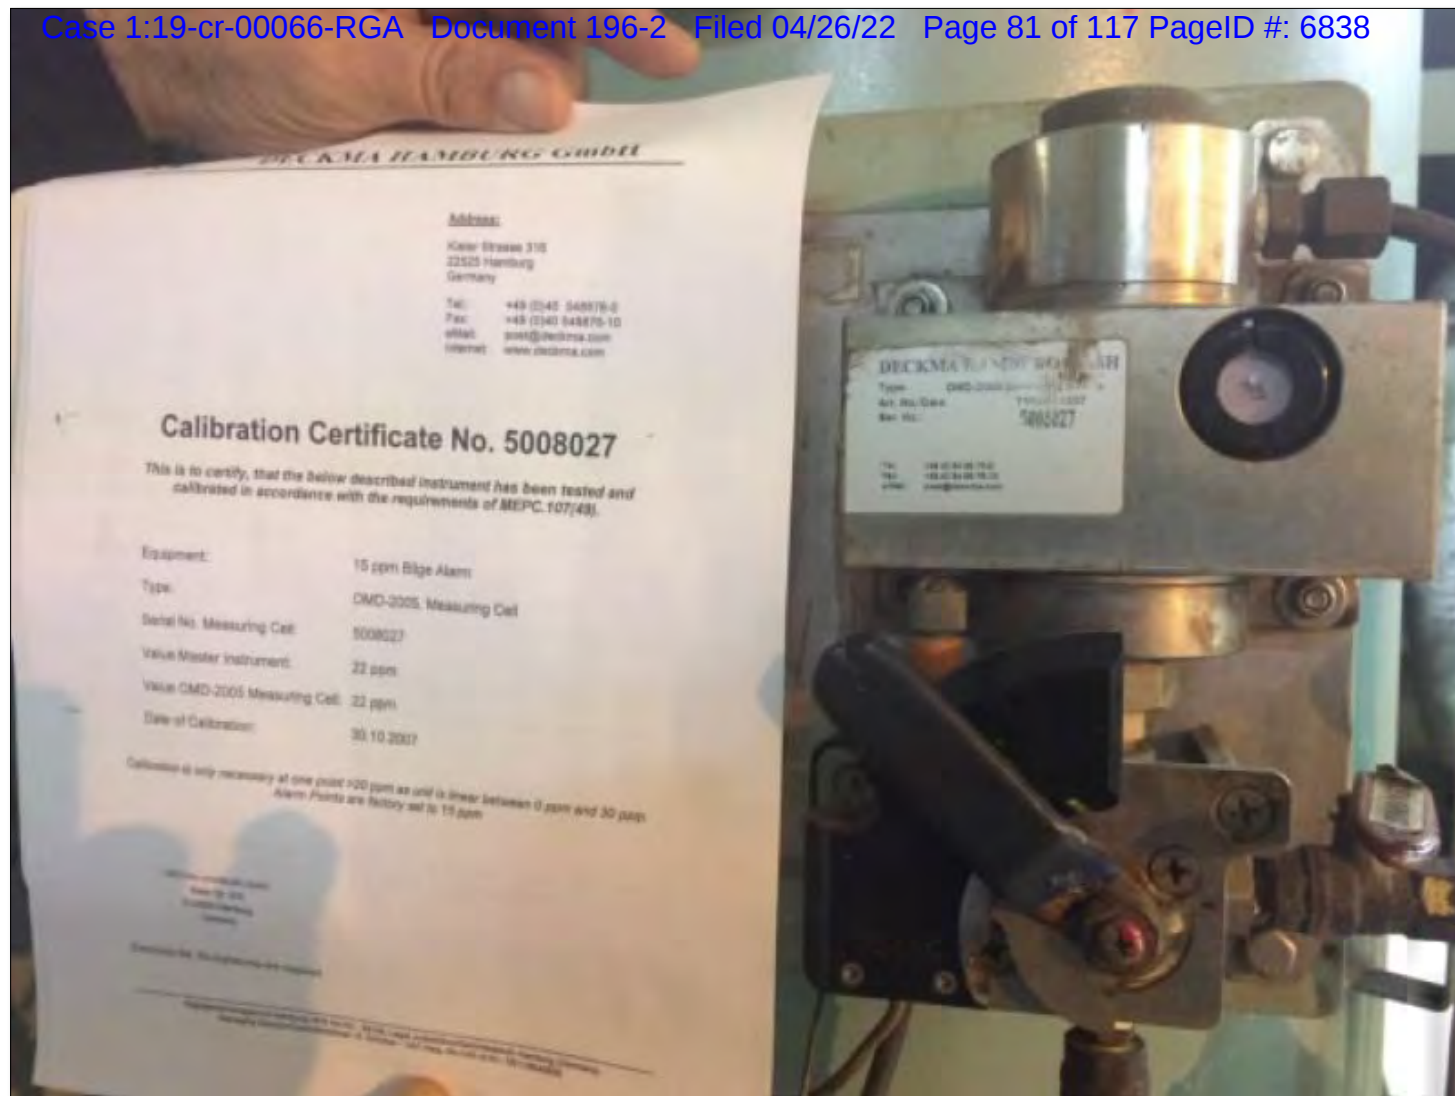
Slide 5

The certificate on the left side of this JPEG image, and dated 30.10.2007, was issued by Deckma at the time of delivery in 2017. It is the same certificate as Slide 2. This photograph of the certificate with the unit was emailed from the ship on April 5, 2018, after the BP inspection.

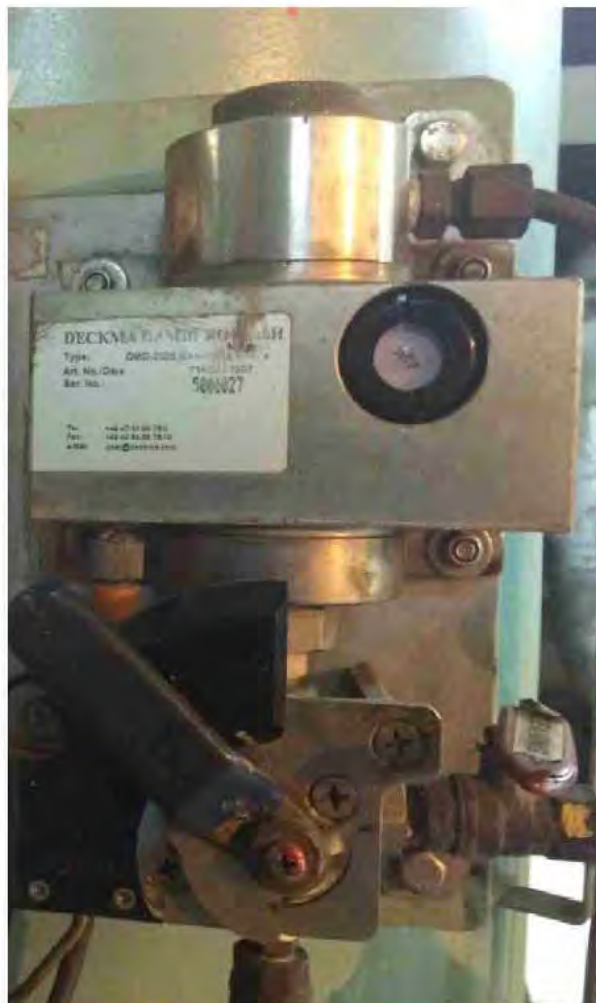
The OCM Calibration Certificate on the left side of this PDF was not issued by Deckma according to Deckma. It is apparently the same as the authentic 2007 certificate depicted in Slides 2 and 5, except that the year has been modified.

The certificate on the left side of this PDF document has been pasted on top of the photograph in Slide 5. A portion of the 2007 certificate remains visible as shown in the next slide.

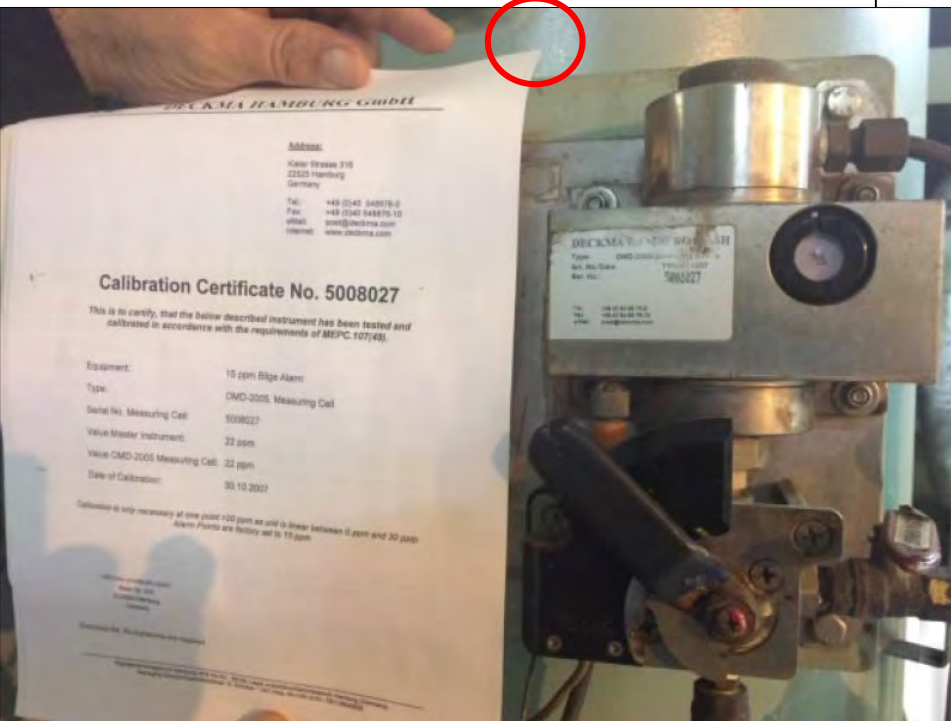
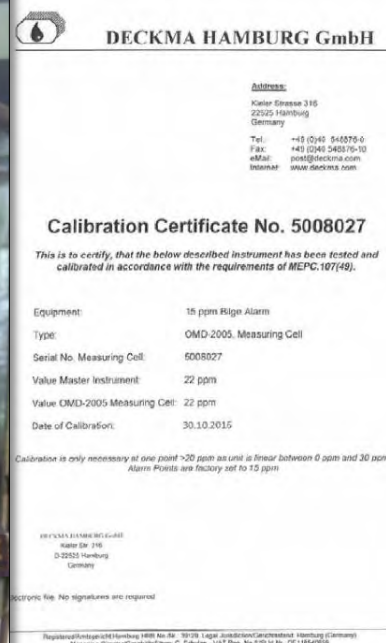
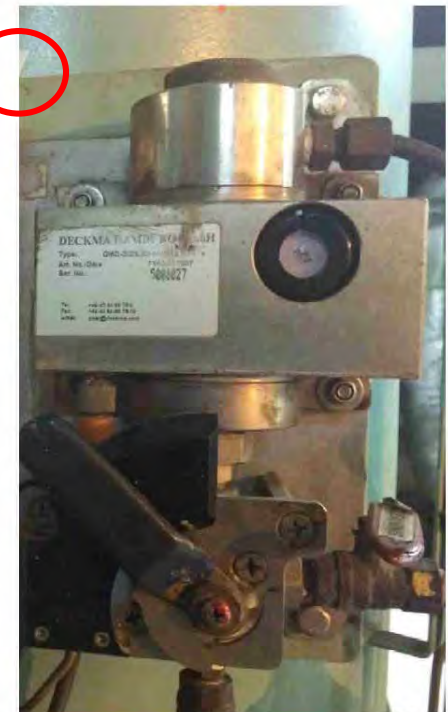
Oil water separator

This slide shows a side-by-side depiction of the same photograph of OCM unit 5008027 with two different OCM calibration certificates. The 2016 PDF document on right was created on computer with an embedded profile linked to D. Liveris. JPEG photo on left was sent from the ship to Liquimar on April 5, 2018 and is embedded in the PDF on the right. The circled portion of both images shows the upper right corner of the OCM certificate on the left still visible in the edited image on the right. According to the metadata, the PDF document on right was created on April 12, 2018. This certificate was found attached to an email string dated April 23, 2018 from Liquimar to the ship that was written in Greek.
